FLIR B-Series infrared camera tells truth about walls and facades

Building insulation quality becomes a pressing issue as heating costs soar. An infrared camera for building applications and the expert's eye can do a lot to save on energy.

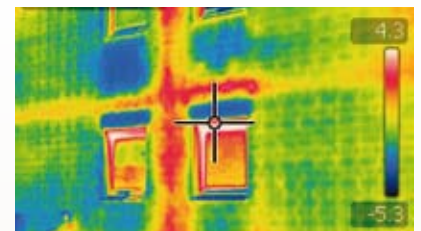
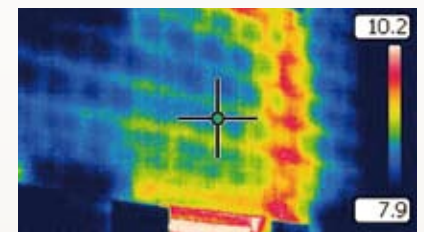
Examples of inefficient piping insulation between kitchen and bathroom

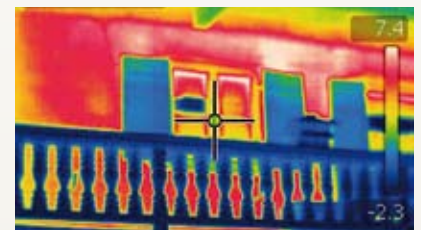
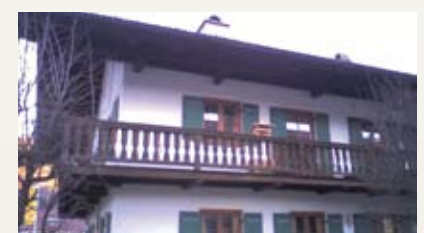
Bad insulation above balcony window
