APPLICATION STORY

The Västmanlands district main hospital, Västerås, Sweden

FLIR InfraCAM™ and E-Series infrared cameras save repair time and heating costs at hospital group

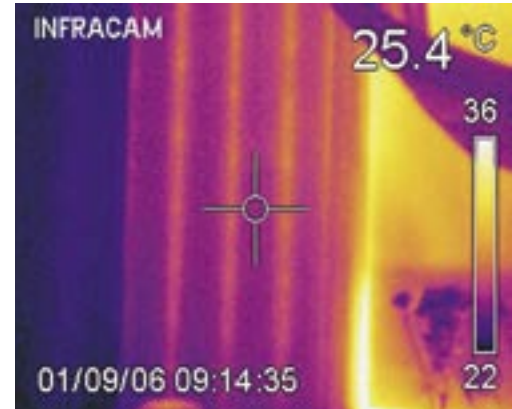
The image clearly shows where not to drill.

The infrared camera is also used by other contractors such as plumbers to look at water piping systems, especially prior to repair work, to be able to see where to drill (or not to drill), where (not) to break open floors or walls etc...Its use generates savings that are worth many times the price of a handheld infrared camera.

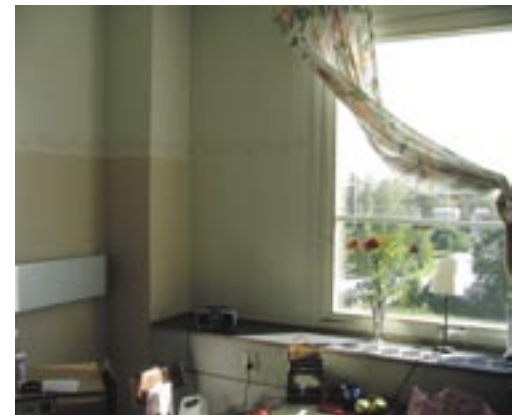
The camera easily detects leaks and moist areas, showing which areas are to be repaired in order to avoid further mold development.
